Manhole Inspection Summary

Manhole # S31E__025MH

Location Address: **side 513 w lexington st**

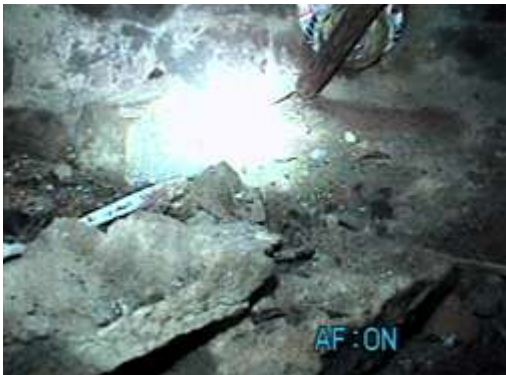
Defect 3

Condition: ☐ Sound ☐ Cracked ☐ Root Intrusion ☐ Deteriorated ☐ Leaks ☒ **Debris**

channel debris

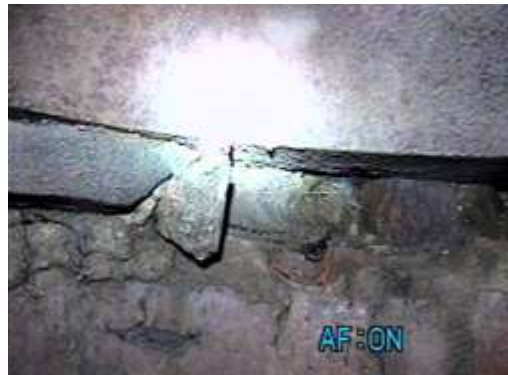
Defect 2

Condition: ☐ Sound ☐ Cracked ☐ Root Intrusion ☒ **Loose Brick** ☒ **Deteriorated**

frame adj

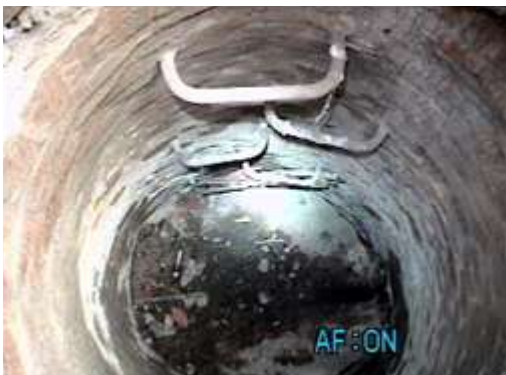
Defect 1

Steps Count: **5** Missing: **0** ☒ **Corroded**

steps corroded
